Mid-Columbia Salmon Recovery Region Indicators

**Mid-Columbia
Salmon Recovery
Region**

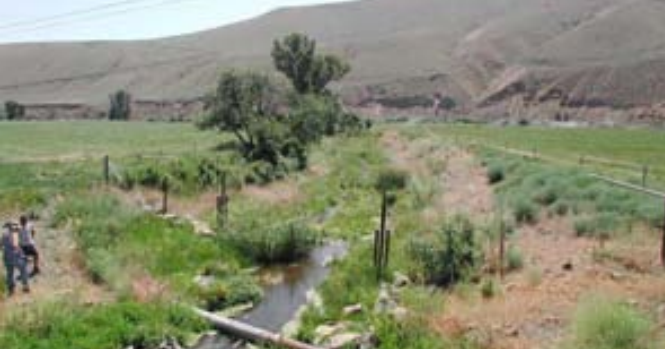
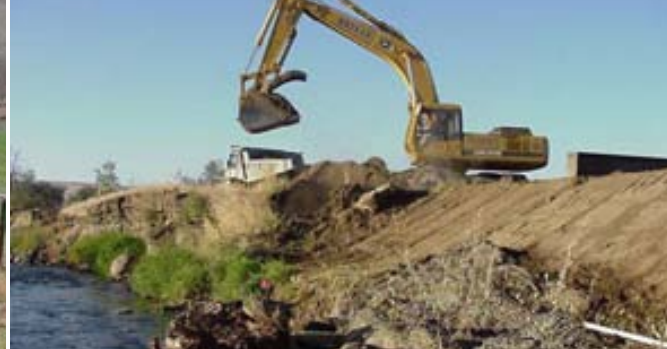
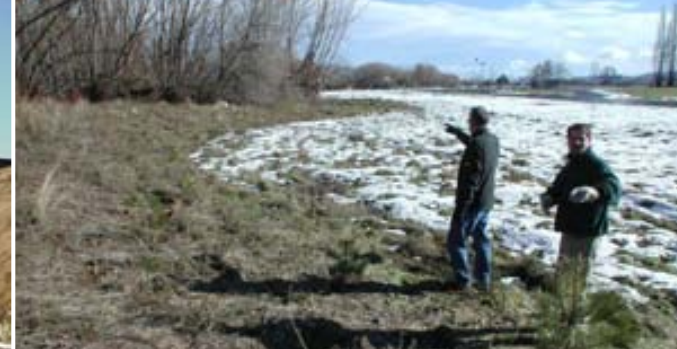
Lmuma Creek Riparian Restoration

This tributary provides the best opportunity for off-channel rearing of salmon in the Yakima Canyon.

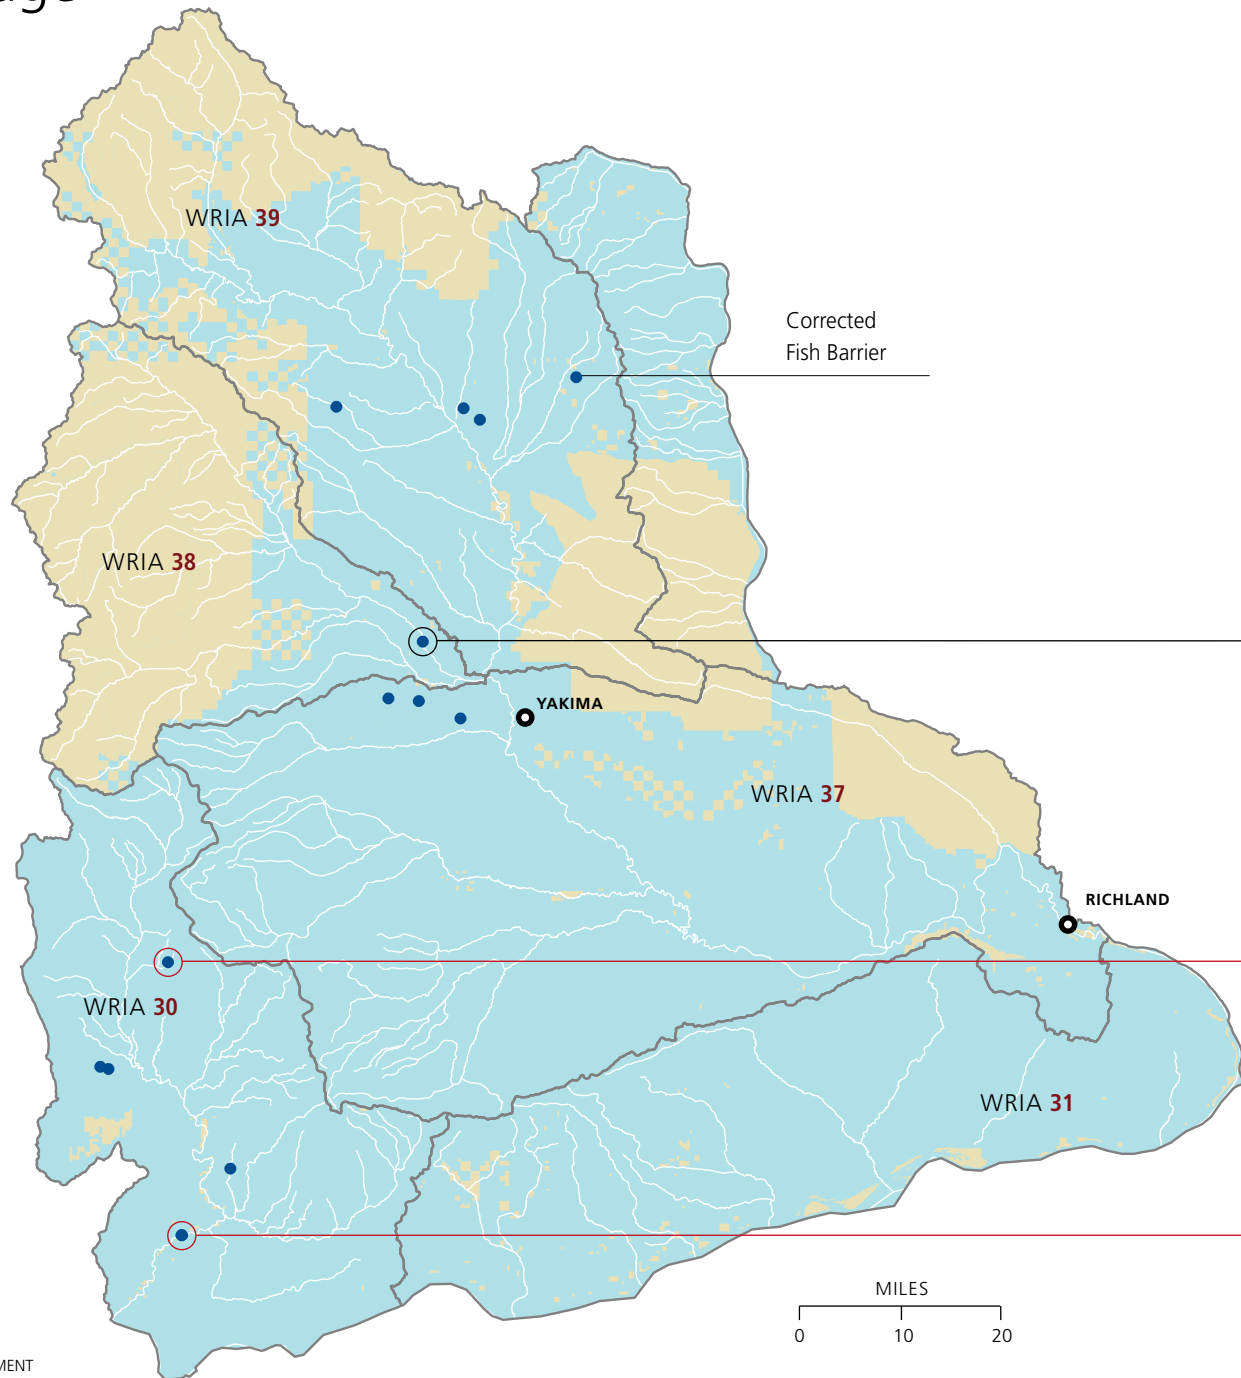
we have chosen to depict barriers independent from the habitat quality map because impaired access to streams is one of the more significant factors limiting salmon. We depict only blockages affecting anadromous fish, and do not show bull trout blockages. The effort to document locations of fish passage barriers repaired since 1999 was just initiated this year (2004), so some projects may not be displayed on this map. This map shows completed projects funded by the Salmon Recovery Funding Board, Washington Department of Transportation, Washington Department of Natural Resources, local governments, or US Forest Service that remove barriers for anadromous fish. We expect ongoing mapping efforts will continue to reveal projects.

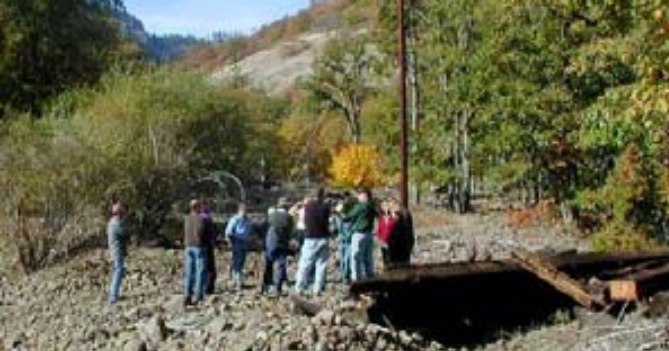
Surveyors Creek Fish Enhancement

This project was designed to give spring Chinook and steelhead access to the excellent juvenile rearing conditions found along upper reaches of Surveyors Creek.

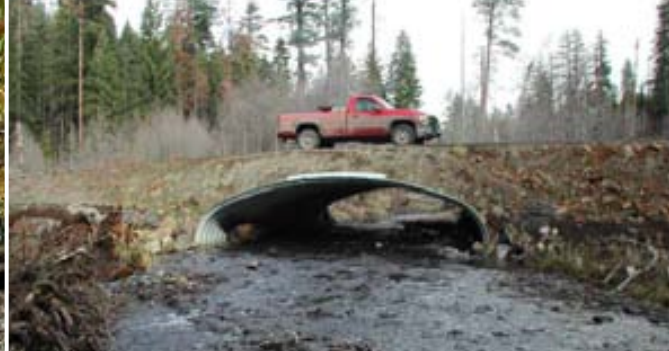
An improperly placed, undersized culvert blocking fish passage was replaced with this one that now allows the creek to function naturally.

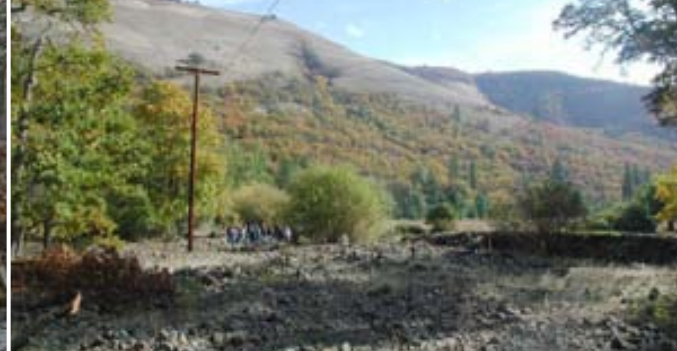
Logging Camp Creek Fish Passage

Logging Camp Creek is a tributary of the Klickitat River. This project re-established historic steelhead access to spawning areas by creating a channel for the fish.

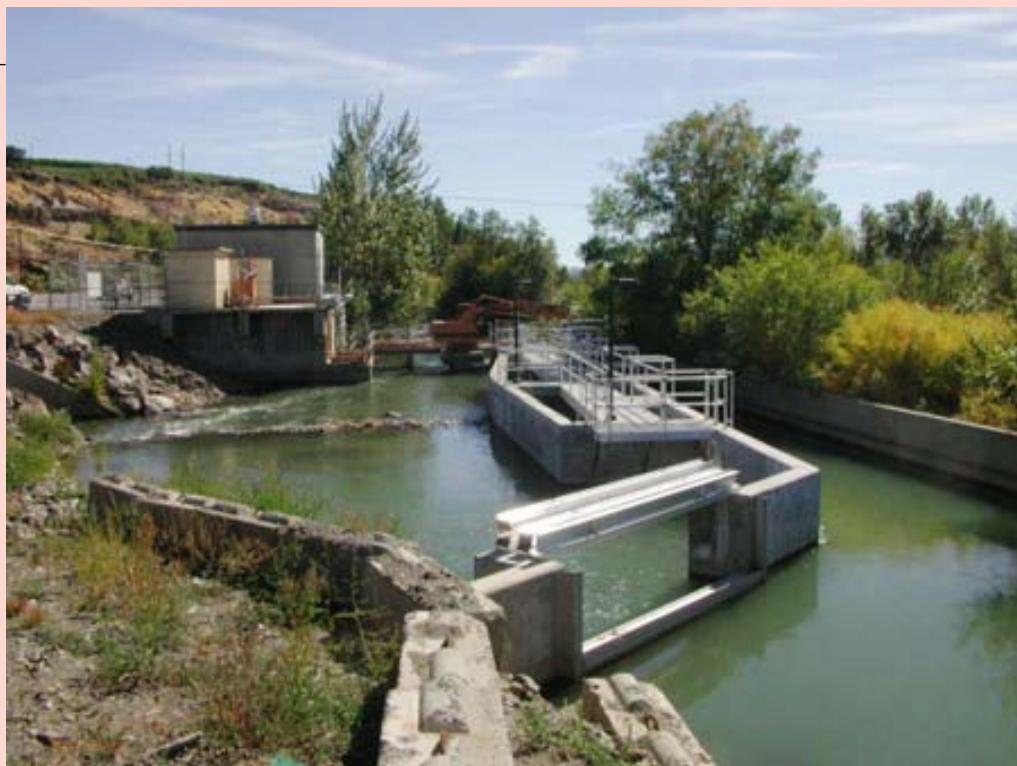
Naches River Fish Screen

The city of Yakima reduced impacts on salmon from maintenance with the installation of fish screens.
